CASE STUDY: PIGEON LOCKOUT

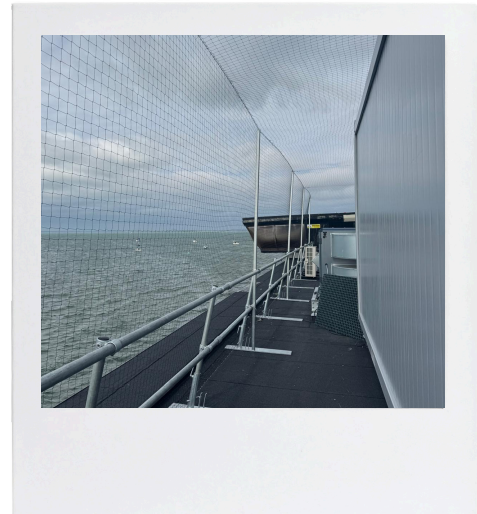
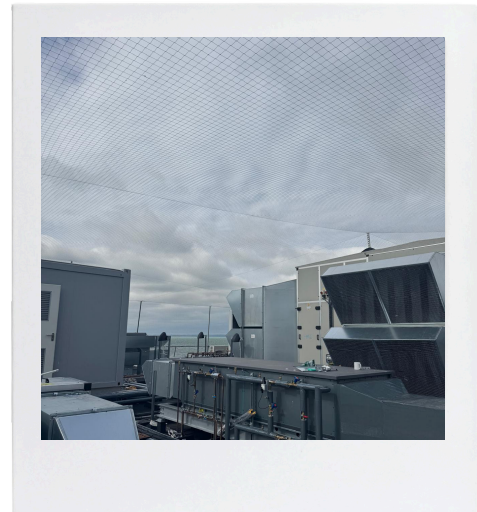
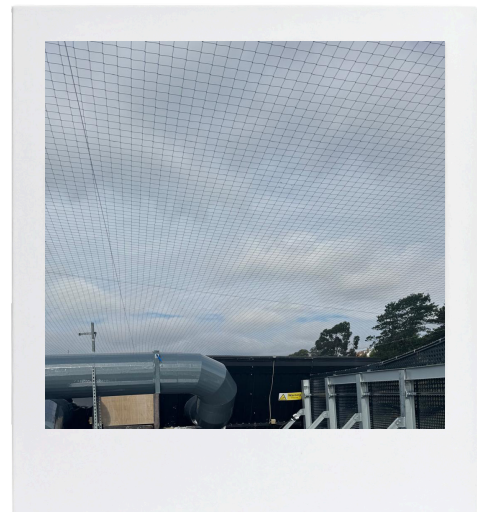
Genting Casino in Southend was battling a major pigeon infestation on its rooftop. The birds were nesting under rooftop plant structures, creating heavy fouling and hygiene risks. The project was initially quoted from plans, but on-site surveys revealed a much larger roof and plant setup than expected. The exposed coastal location, with one side open to the sea, and the height of the plant housings made standard roof-mounted netting solutions impossible.

Using existing railings and barriers, they integrated unistruts to raise the netting high enough for maintenance access while ensuring maximum durability. The installation included

- **400m** of 2mm 7-strand stainless steel wire
- **40** stainless M6 barrel strainers & copper ferrules
- **1,500** “L” brackets & 40 corner fixing mounts
- **20,000+** SR8 grade 304 c-ring staples
- **10** 10×10m and **4** 5×10m black pigeon nets
- **12-gauge** hot-dipped galvanised steel weldmesh (50mm mesh)

The casino’s rooftop is now fully protected against pigeons with a robust, weather-resistant netting system that allows safe maintenance access. Thanks to the high-quality materials supplied by PestFix and expert installation by British Bird Control, the solution will prevent future nesting and fouling for years to come, keeping the site clean, compliant, and pest-free.
